**Flood Control Project Maintenance  
Levee Inspections**

**Maintenance Issue Types Only, Levee Inspection Report By Mile - Fall 2018**

**Reclamation District No. 0817 Carlin**

Waterway	Bank	Unit Miles	Inspection Start/End	Inspector
Unit No. 01 South Dry Creek	Left	3.81	11/01/2018 11/01/2018	Sterling York

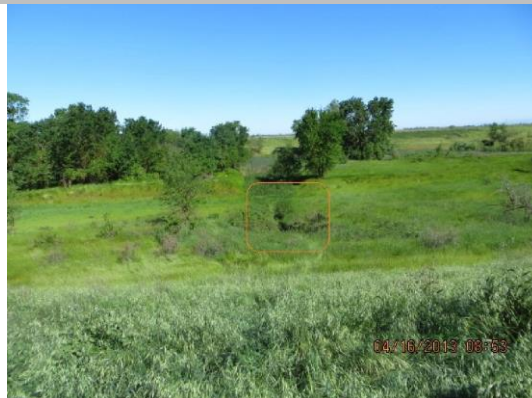
Photo 3 of 3 : UCIP\_FA\_2018\_42685\_19863.jpg

LM Start	0.29	Rating **	M	Issue No.	28 (cont)	
LM End	0.29	Issue Type +	Ma	Location *		
Category	Supplemental			GPS Latitude/Longitude		
				Start		End
Item	DWR UCIP LMA Responsibility			38.987813 °		38.987813 °
				-121.502963 °		-121.502963 °
DWR ID	18985					
Comment Code						
Inspector Comment						
FS_ID:42685 DS_ID:18985 EP_NO: N/A Repair Type: Non-Urgent Crossing Status: Found UCIP Comments: 04/16/2013 Dense vegetation on waterward and landward slopes limit visual inspection of potential leaks along pipe alignment. Recommend having owner clear vegetation along slopes. (P. Amatya - DWR UCIP) FIELD_STRUCT_DESC: 48-inch corrugated metal gravity drainage pipe through the levee, 23.3 feet below the crown. Flap gate on the waterside (WS) end. [Additional Reference(s): DWR Levee Log, 2005. USACE Sacramento O&M Manual 146, November 1962, (HLM 0.28)]. FS Date: 4/16/2013

WS- dense vegetation on WS of the levee

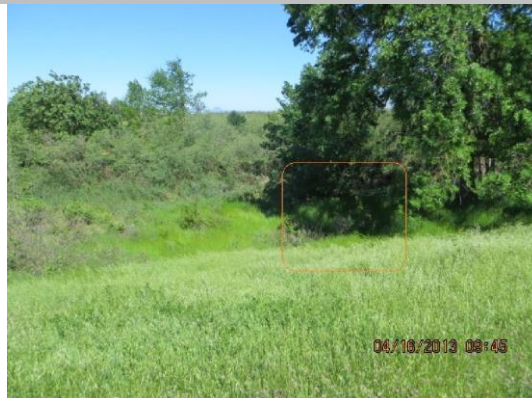
Photo 1 of 3 : UCIP\_FA\_2018\_41153\_19882.jpg

Comment Code						
Inspector Comment						
FS_ID:41153						
DS_ID:18987						
EP_NO: N/A						
Repair Type: Non-Urgent						
Crossing Status: Found						
UCIP Comments: 04/16/2013 Damaged slide gate on WS of the levee.						
Need to contact owner to determine status of crossing. If crossing is no						
longer in use owner will need to contact CVFPB to comply with Title 23.						
Dense vegetation on waterward and landward slopes limit visual						
inspection of potential leaks along pipe alignment. Recommend having						
owner clear vegetation along slopes. (P. Amatya - DWR UCIP)						
FIELD_STRUCT_DESC: *ABANDONED* 18-inch corrugated metal						
gravity drainage pipe through the levee, 14.9 feet below the crown.						
Slide gate on the waterside (WS) end. [Additional Reference(s): DWR						
Levee Log, 2005. USACE Sacramento O&M Manual 146, November						
1962, (HLM 1.34)].						
FS Date: 4/16/2013

WS- overview of WS area

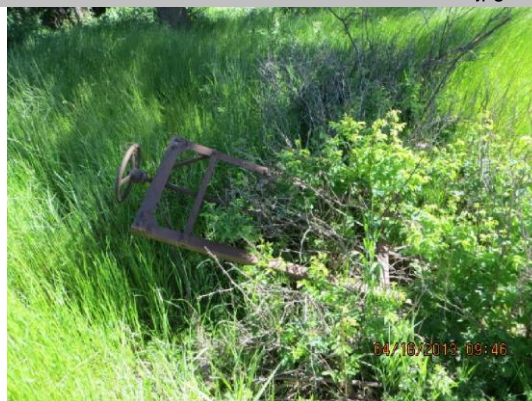
Photo 2 of 3 : UCIP\_FA\_2018\_41153\_19881.jpg

Comment Code						
Inspector Comment						
FS_ID:41153 DS_ID:18987 EP_NO: N/A Repair Type: Non-Urgent Crossing Status: Found UCIP Comments: 04/16/2013 Damaged slide gate on WS of the levee. Need to contact owner to determine status of crossing. If crossing is no longer in use owner will need to contact CVFPB to comply with Title 23. Dense vegetation on waterward and landward slopes limit visual inspection of potential leaks along pipe alignment. Recommend having owner clear vegetation along slopes. (P. Amatya - DWR UCIP) FIELD_STRUCT_DESC: *ABANDONED* 18-inch corrugated metal gravity drainage pipe through the levee, 14.9 feet below the crown. Slide gate on the waterside (WS) end. [Additional Reference(s): DWR Levee Log, 2005. USACE Sacramento O&M Manual 146, November 1962, (HLM 1.34)]. FS Date: 4/16/2013

WS- closer look at damaged slide gate on WS

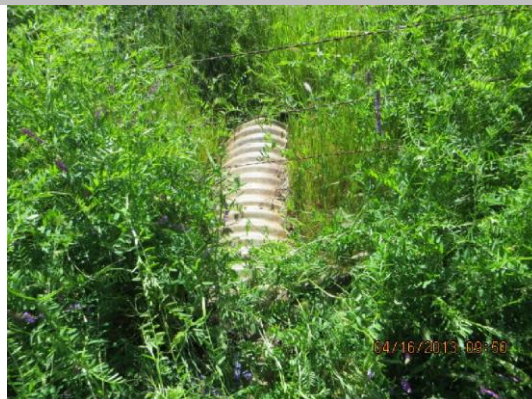
Photo 3 of 3 : UCIP\_FA\_2018\_41153\_19884.jpg

LS- CMP on toe of the levee.

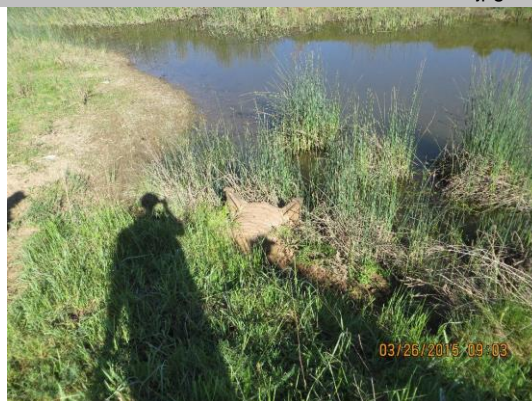
Photo 1 of 3 : UCIP\_FA\_2018\_43946\_73422.jpg

Comment Code					
Inspector Comment					
FS_ID:43946					
DS_ID:18992					
EP_NO: N/A					
Repair Type: Non-Urgent					
Crossing Status: Found					
UCIP Comments: 03/26/2015 Flapgate in closed position, but blocked from operation on WS toe. Pipe appears abandoned and should be verified as having been done so properly. (W. Wylie - DWR UCIP)					
FIELD_STRUCT_DESC: 36-inch corrugated metal gravity drainage pipe through the levee, 13.7 feet below the crown. Slide gate on the waterside (WS) end. Flap gate on the WS end. [Additional Reference(s): DWR Levee Log, 2005. USACE Sacramento O&M Manual 146, November 1962, (HLM 2.97)].					
FS Date: 3/26/2015

Pipe and flapgate visible on WS toe.

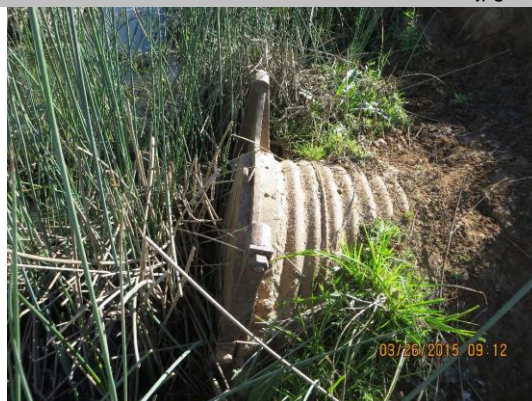
Photo 2 of 3 : UCIP\_FA\_2018\_43946\_73421.jpg

Comment Code						
Inspector Comment						
FS_ID:43946						
DS_ID:18992						
EP_NO: N/A						
Repair Type: Non-Urgent						
Crossing Status: Found						
UCIP Comments: 03/26/2015 Flapgate in closed position, but blocked from operation on WS toe. Pipe appears abandoned and should be verified as having been done so properly. (W. Wylie - DWR UCIP)						
FIELD_STRUCT_DESC: 36-inch corrugated metal gravity drainage pipe through the levee, 13.7 feet below the crown. Slide gate on the waterside (WS) end. Flap gate on the WS end. [Additional Reference(s): DWR Levee Log, 2005. USACE Sacramento O&M Manual 146, November 1962, (HLM 2.97)].						
FS Date: 3/26/2015

Pipe and flapgate visible on WS toe.

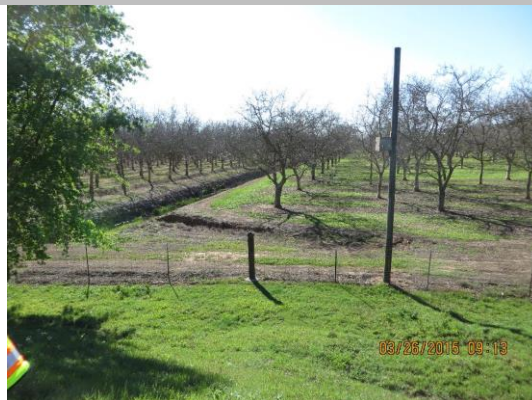
Photo 3 of 3 : UCIP\_FA\_2018\_43946\_73420.jpg

LS of pipe buried but alignment would place LS outlet just left of telephone pole on LS toe.

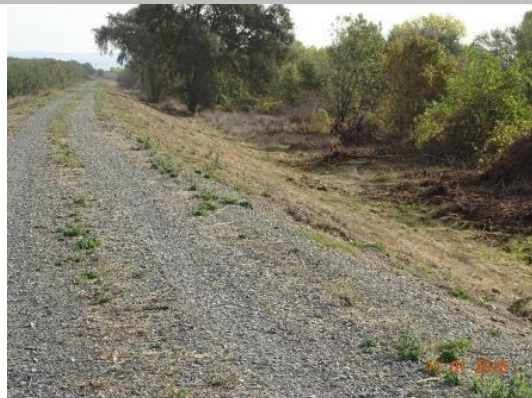
Photo 1 of 1 : FA\_2018\_RD0817\_13\_10\_20181107\_00025.jpg

View looking upstream waterside of the well maintained annual vegetation, Fall 2018.

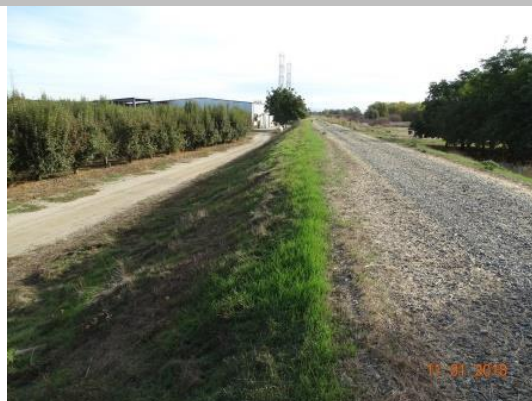
Photo 1 of 1 : FA\_2018\_RD0817\_13\_9\_20181107\_00026.jpg

LM Start	0.00	Rating **	A	Issue No.	9
LM End	3.82	Issue Type +	Ma	Location *	LS
Category	Earthen Levee			GPS Latitude/Longitude	
				Start	End
Item	Vegetation			38.984668 °	38.993136 °
				-121.506106 °	-121.437905 °
DWR ID	DWR_RD0817_02_f_2018_9				
Comment Code					
V1 : Control annual grass and weeds on the levee slopes and easements.					
Inspector Comment					
The annual vegetation is well maintained, Fall 2018.

View looking upstream landside of the well maintained annual vegetation, Fall 2018.

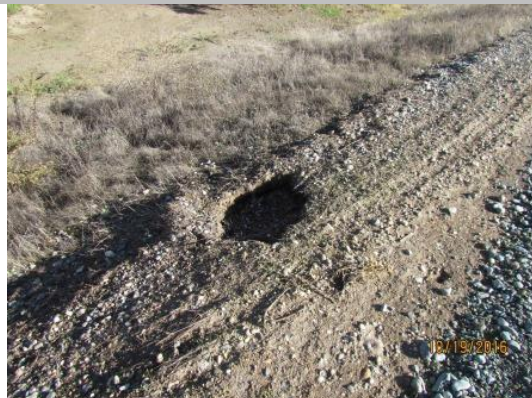
Photo 1 of 1 : FA\_2018\_RD0817\_13\_15\_20180918\_00011.jpg

LM Start	1.47	Rating **	M	Issue No.	15
LM End	1.47	Issue Type +	Ma	Location *	LS
Category	Earthen Levee			GPS Latitude/Longitude	
				Start	End
Item	Erosion / Bank Caving			38.986563 °	38.986563 °
				-121.479509 °	-121.479509 °
DWR ID	DWR_RD0817_02_f_2016_15				
Comment Code					
E2 : Schedule repair of erosion site prior to the next inspection.					
Inspector Comment					
Sink hole were old stump was needs to be backfilled and compacted.

View of a sink hole were old stump was. This needs to be backfilled and compacted.

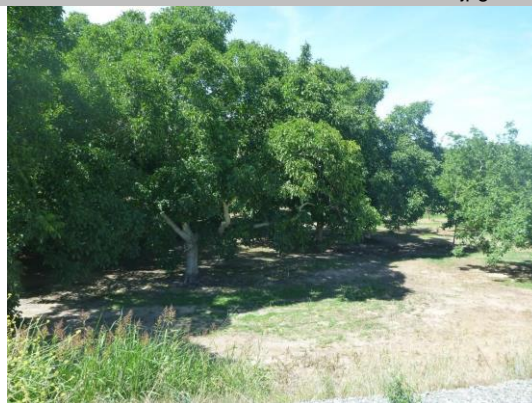
Photo 1 of 3 : LEVAL\_FA\_2018\_162\_287.jpg

LM Start	2.08	Rating **	A/W	Issue No.	13	
LM End	3.18	Issue Type +	Ma	Location *		
Category	Supplemental			GPS Latitude/Longitude		
				Start	End	
Item	2017 Storm Damage			38.989338	°	38.994124
				-121.468640	°	-121.449448
DWR ID	DWR_RD0817_02_f_2017_13					
Comment Code						
Inspector Comment						
Levee Evaluation Comments						
Description:						
Site ID No:162						
Site Designation:DWR_RD0817_02_s_2012_10						
Repair Type: Stability						
Rating:Area of Concern						
Field Date:6/5/2017						
Notes: Stability issues are due to levee geometry. Narrow steep slopes.

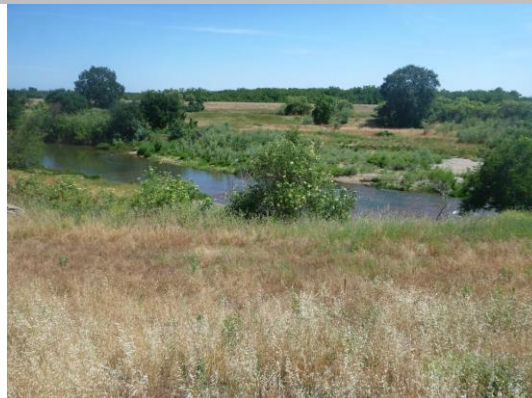
Photo 2 of 3 : LEVAL\_FA\_2018\_162\_288.jpg

LM Start	<b>2.08</b>	Rating **	A/W	Issue No.	<b>13 (cont)</b>
LM End	<b>3.18</b>	Issue Type +	Ma	Location *	
Category	Supplemental		GPS Latitude/Longitude		
			Start	End	
Item	2017 Storm Damage		38.989338°	38.994124°	
			-121.468640°	-121.449448°	
DWR ID	DWR_RD0817_02_f_2017_13

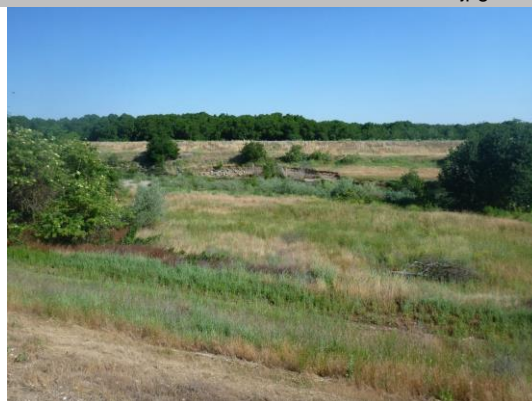
Photo 3 of 3 : LEVAL\_FA\_2018\_161\_291.jpg

LM Start	2.72	Rating **	A/W	Issue No.	14 (cont)
LM End	2.74	Issue Type +	Ma	Location *	
Category	Supplemental			GPS Latitude/Longitude	
				Start	End
Item	2017 Storm Damage			38.992170 °	38.992217 °
				-121.457332 °	-121.456967 °
DWR ID	DWR_RD0817_02_f_2017_14				
Comment Code					
Inspector Comment					
Levee Evaluation Comments					
Description:					
Site ID No:161					
Site Designation:240-3					
Repair Type: Erosion					
Rating:Area of Concern					
Field Date:6/5/2017					
Notes: No issue found. Narrow levee with steep slopes. Did not investigate bench due to rattlesnake concerns. Possible alternate location at 38.993282; -121.451562.

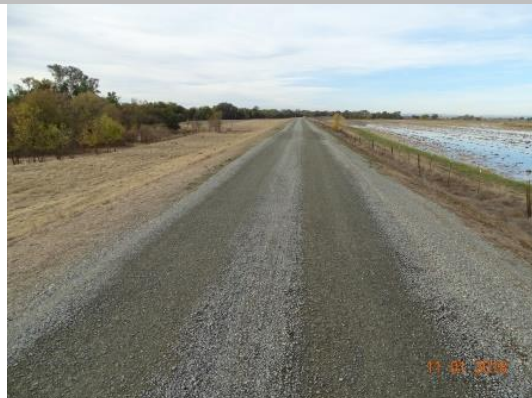
Photo 1 of 1 : FA\_2018\_RD0817\_14\_13\_20181107\_00032.jpg

View looking downstream crown that has been resurfaced with aggregate base, Fall 2018.

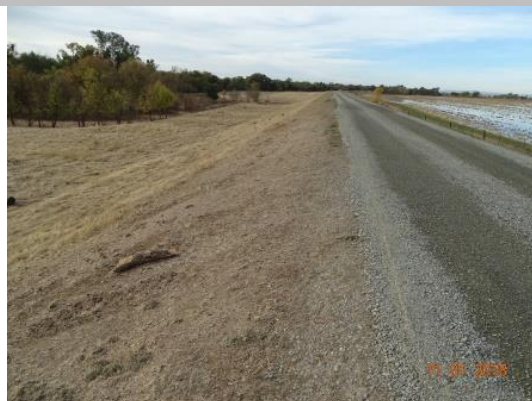
Photo 1 of 1 : FA\_2018\_RD0817\_14\_10\_20181107\_00030.jpg

LM Start	0.25	Rating **	A	Issue No.	10
LM End	1.27	Issue Type +	Ma	Location *	WS
Category	Earthen Levee			GPS Latitude/Longitude	
				Start	End
Item	Vegetation			38.987590 °	38.996883 °
				-121.506622 °	-121.491936 °
DWR ID	DWR_RD0817_03_f_2018_10				
Comment Code					
V1 : Control annual grass and weeds on the levee slopes and easements.					
Inspector Comment					
The annual vegetation is well maintained, Fall 2018.

View looking downstream waterside of the annual vegetation that is well maintained, Fall 2018.

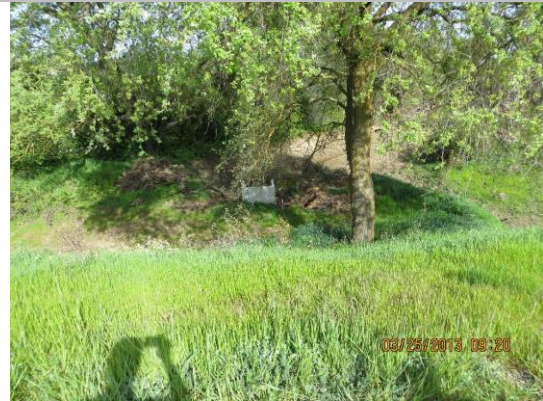
Photo 3 of 3 : UCIP\_FA\_2018\_53421\_53852.jpg

Comment Code					
Inspector Comment					
FS_ID:53421 DS_ID:22951 EP_NO: N/A Repair Type: Urgent Crossing Status: Found UCIP Comments: 10/30/2018 Same as last inspection. Pipe wall has corroded significantly (pipe wall missing) at the outlet. Spoke with Tom Engler (MBK Engineers), District Engineer, and he mentioned that a video inspection has been completed at this site and that a report is in progress. LMA will be seeking funding for pipe repair under DWR's Deferred Maintenance Project (DMP). Crossing remains Urgent due to the deteriorated condition of the pipe. (O. Magana - DWR UCIP)(O. Magana - DWR UCIP)06/30/2016 Corrosion still present on WS end. Inlet box was replaced 5 years ago and appears to be functioning properly due to the presence of a screen that prevents debris blockage. Flap gate functions properly only sometimes. WS heavily vegetated. (K. Fazel - UCIP) 03/25/2013 Corrosion holes on WS toe and flap gate is blocked by debris. Flap gate broken. Inlet partially blocked at concrete inlet. (G. Wylie - FPIIB) FIELD_STRUCT_DESC: 24-inch corrugated metal gravity drainage pipe through the levee, 20 feet below the crown. Flap gate and headwall on the waterside (WS) end. 56-inch by 34-inch concrete inlet box on the landside (LS) toe. (Due to a recent change in the levee alignment, this pipe is no longer in RD0784, Unit 6. Nevertheless, this pipe's original references remain in the RD0784 Levee Log and O&M Manual). [Additional Reference(s): DWR Levee Log, 2005. USACE Sacramento O&M Manual 145.1, August 1955, (Station 43+17), As-Built Drawing No. 2-4-106, Sheet 4, (Station 43+17)]. FS Date: 10/30/2018 1:51:00 PM

Improvised concrete inlet on LS toe.
